John Betjeman Awards 2018

And the winner is... Death Reawakened at Guild Chapel, Stratford-upon-Avon

Project manager **Cate Statham** writes about this year's remarkable winning project

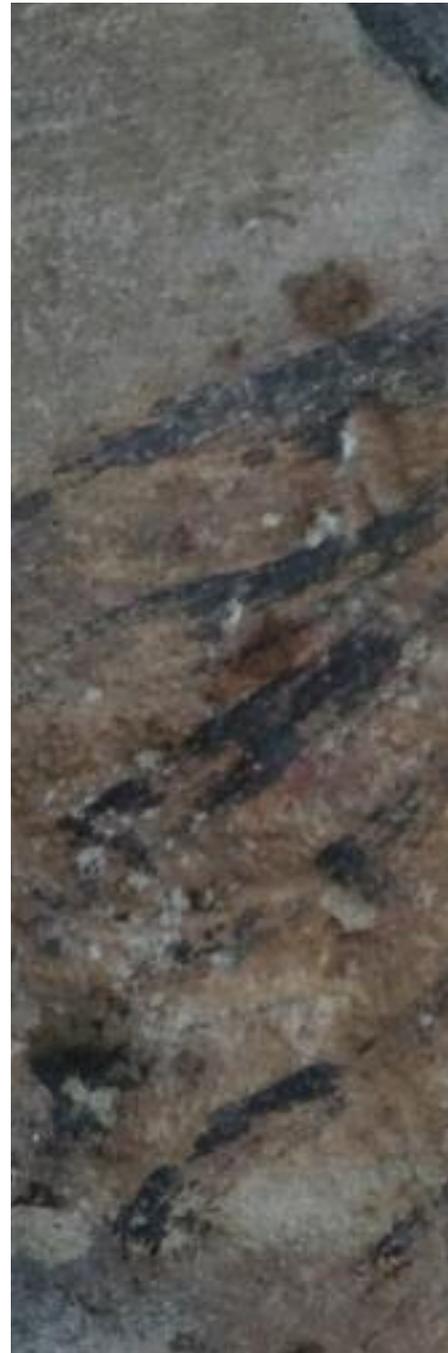
Below left:
Detail from
Erthe upon
Erthe painting
after
conservation

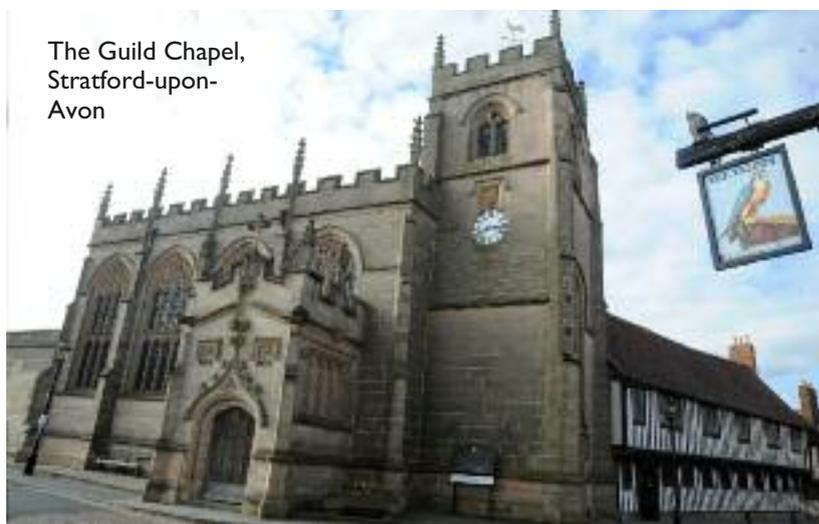
The Guild Chapel,
Stratford-upon-
Avon

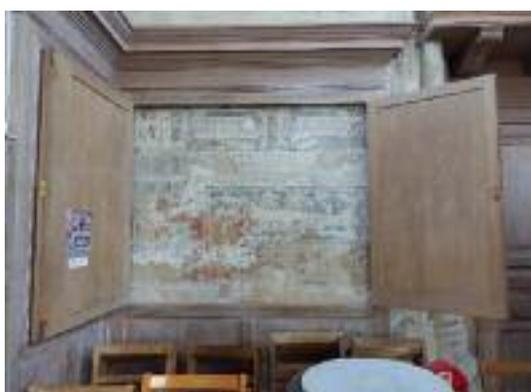
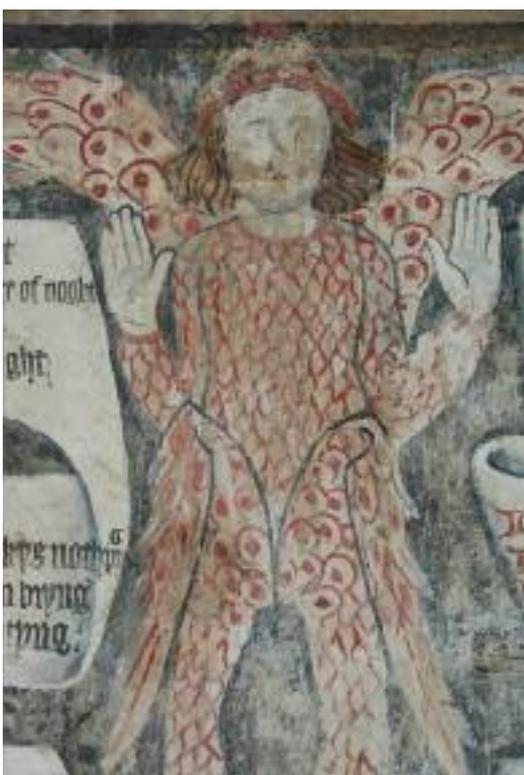
Left: Erthe upon Erthe after conservation

Centre: Erthe upon Erthe before conservation

Below: St Michael from the conserved Erthe upon Erthe

lime plaster repairs that were loose, proud of the surface or overlapping painted detail were replaced. All repair plaster was toned with limewash grounds and watercolour washes so they recede into the background and do not distract from the surviving painted detail. To enhance the clarity of surviving painted detail, distracting small lacunae within otherwise coherent areas of the scheme were reintegrated (toned-in) using conservation grade acrylic-based pigments in a technique obvious on close inspection. This process enhanced the clarity of the scheme without compromising its originality. Also it serves as a visual guide for monitoring future losses.

Sample analysis confirmed the painting was applied directly onto the dressed stone, with two layers of white preparatory ground. The pigments include lead white and carbon black. The blue in the eyes is indigo mixed with white lead. The pink cheeks are small particles of vermilion in white-lead. The lips of the figures are a mixture of red-lead and vermilion as are the capital letters and the angel's feathers. The green windows of the buildings were painted using a synthetic copper green pigment.

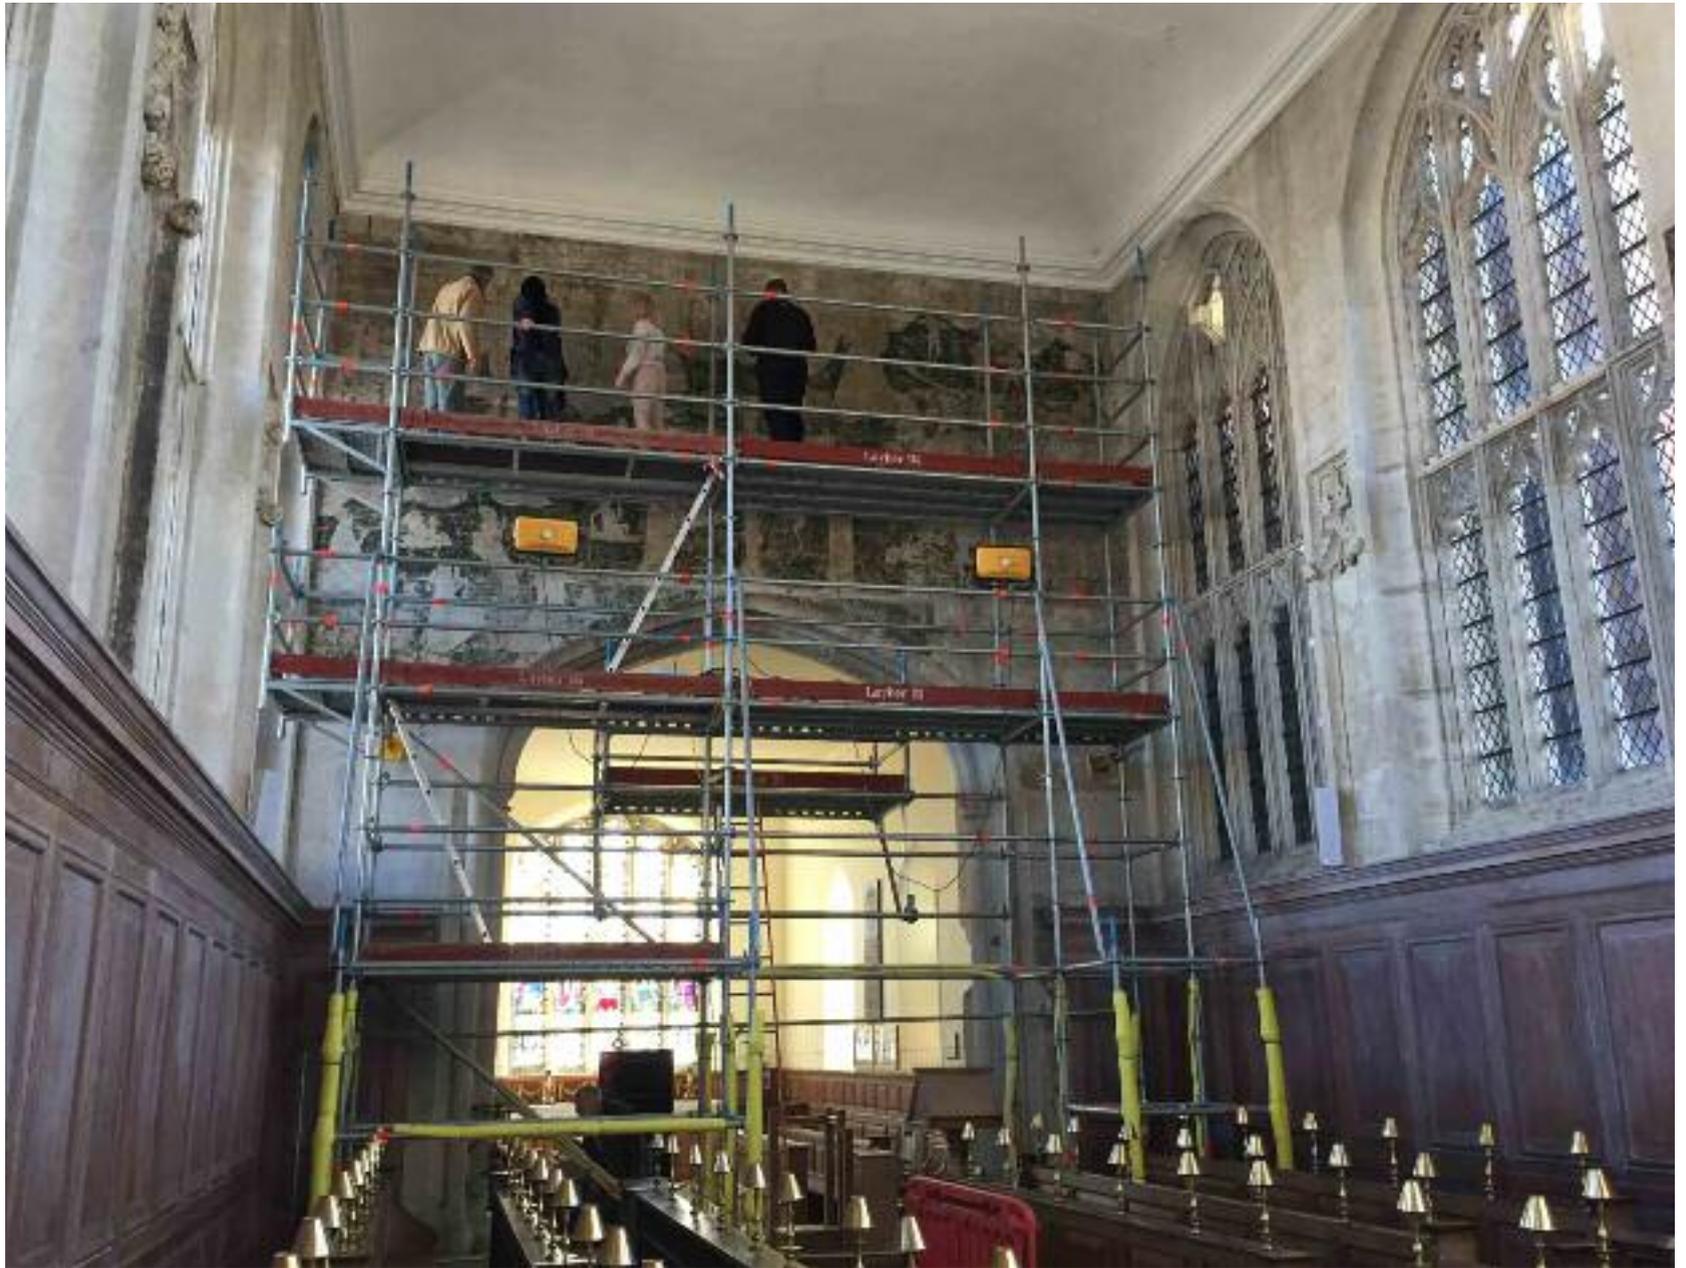
As well as the Doom portion that can be seen within the Chapel, there is also a portion retained above the existing ceiling line (the 15th century ceiling was replaced in 1804 with what is in place today, cutting off the top section of the Doom).

As part of the project, this was accessed and documented, showing Jesus's head and angels still in remarkably good condition. Also, as part of the archive project, a number of timber angels surviving from the 15th century ceiling were also rediscovered.

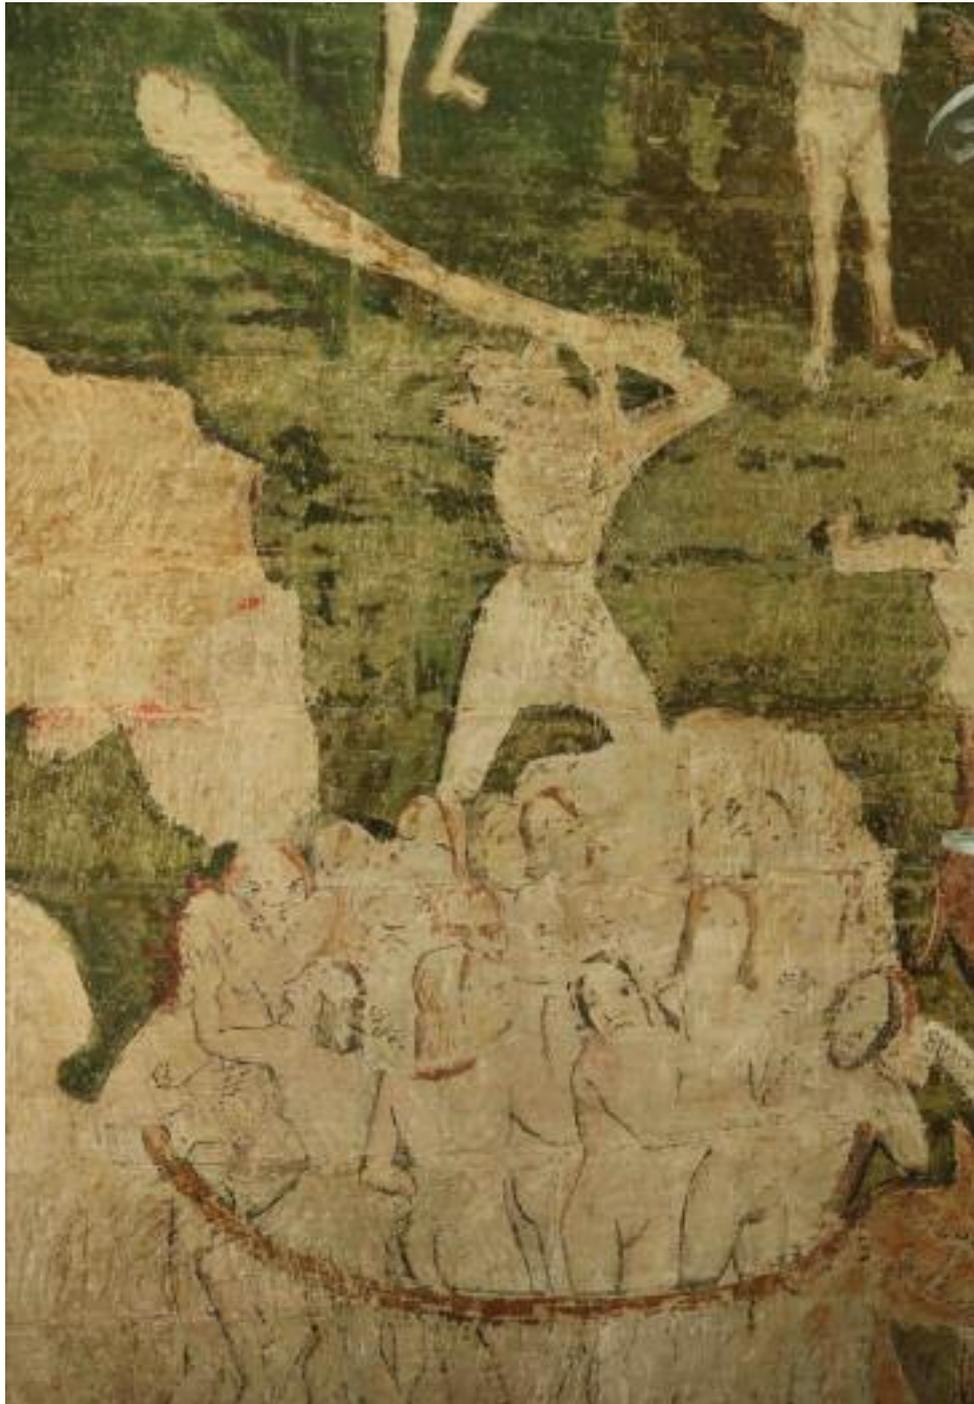
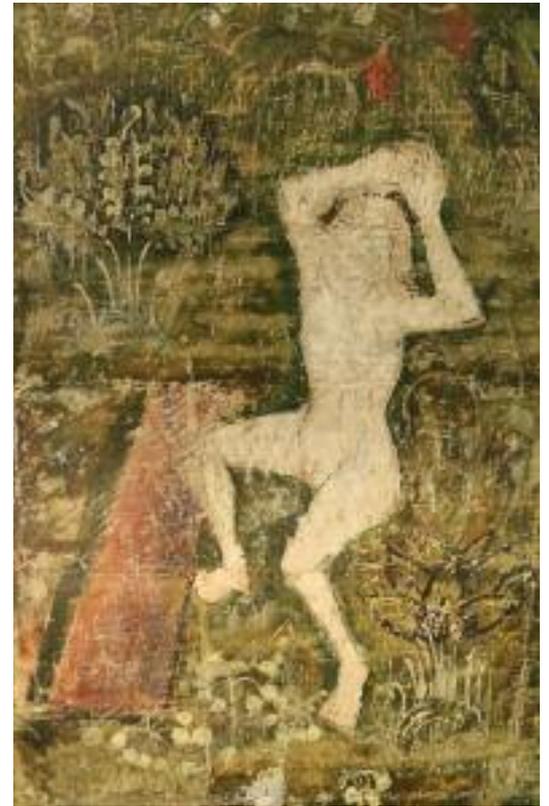
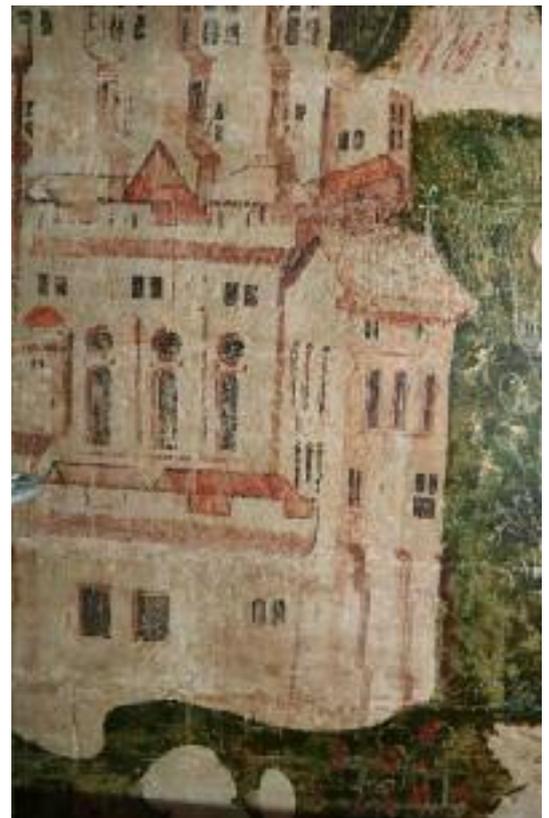
Details of the Doom painting, Damned, left, The Dead Rising, right, and Heaven, below right

The full splendour of this vibrantly coloured scheme had been muted through deterioration of the green paint in particular; this damage is typical in copper resinate-type paints, and is irreversible. Much of the paint surface had also been severely abraded; some of this damage may have been due to intentional iconoclasm or rubbing down prior to overpainting in 16th century, as well as when the covering layers were removed in 1804. The remaining paint was adequately bound but there was significant micro-flaking over large areas.

Paint sample analyses identified a complex technique using coloured under-layers and overlapping, opaque and transparent paints and gilding to create a vivid, almost three-dimensional effect. The painting has an orange/brown ground based on earth colours. Other pigments were found to be as follows:

- Grassy meadow (green) – mixture of Verdigris and copper green in an oil and resin medium;
- Virgin's robe (blue) – azurite;
- Red details (angel's wings, red highlights on the flowers) – pure vermilion;
- Dark-red flowers – organic red lake ;
- Purple flower petals – mixture of yellow and red ochres, carbon black, and some lead white;
- Blonde hair (one soul in a group outside the gates of heaven) – mixture of lead tin yellow and lead white.
- Traces of gold leaf were found on the headdresses of some resurrected souls and St Peter's key.

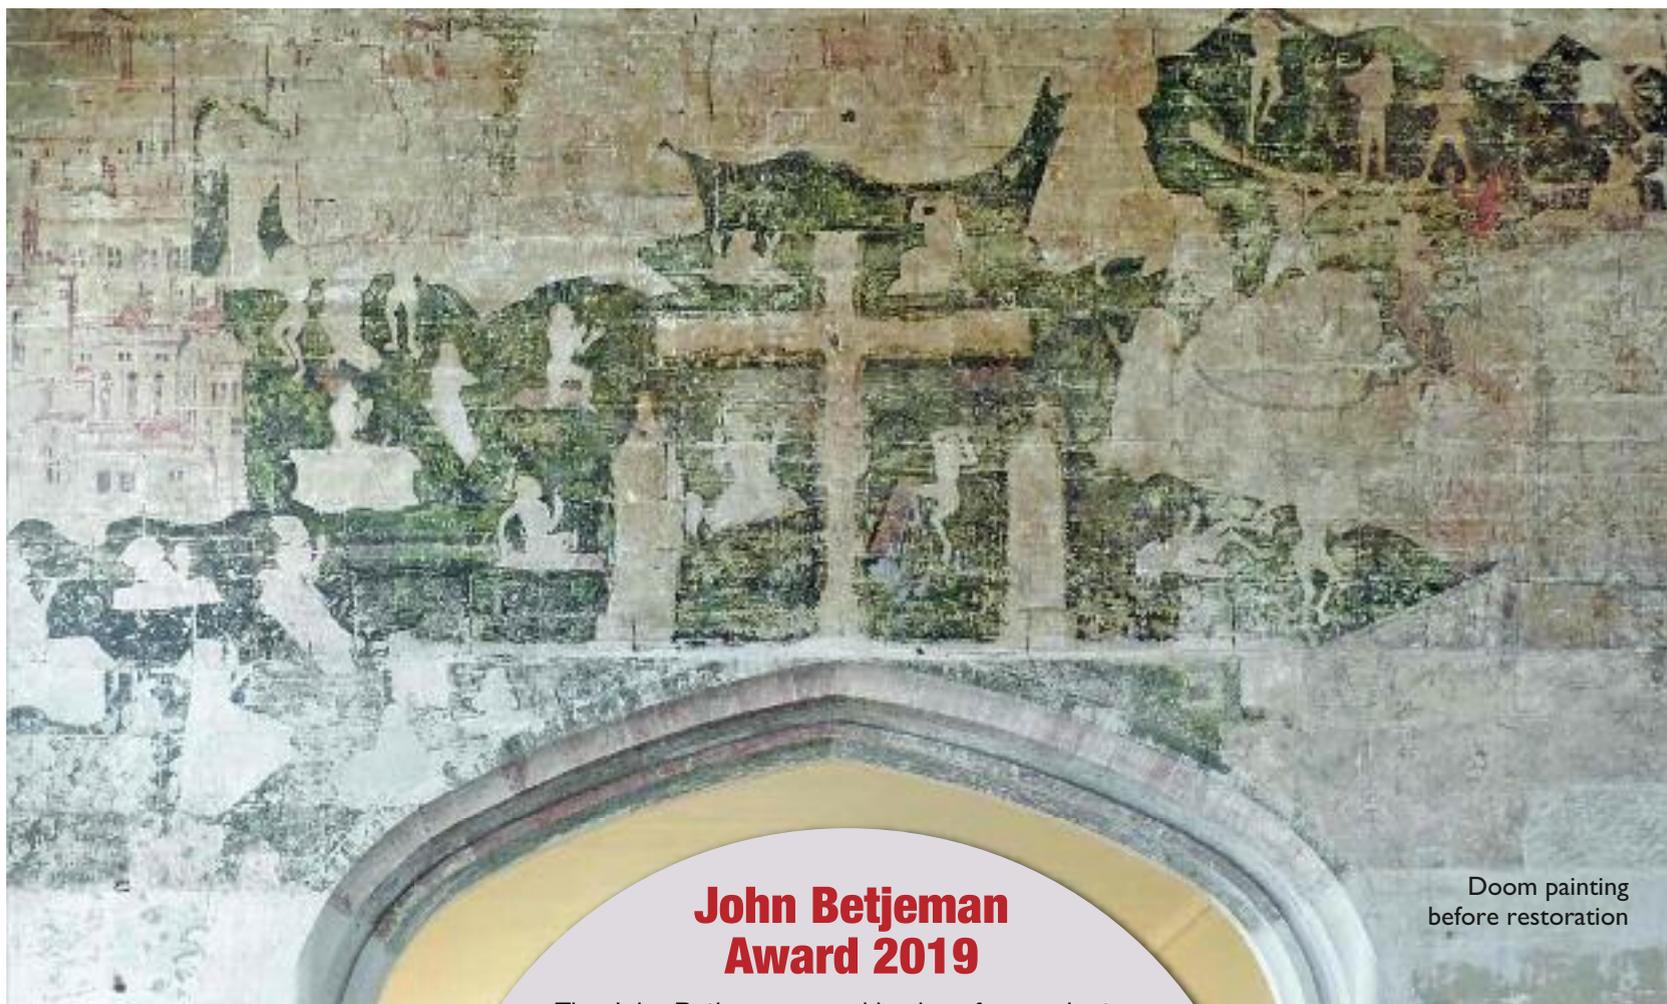
This large scene over the chancel arch had had a wax coating applied in the 1920s, the purpose of which was to consolidate powdering paint, to act as an adhesive for re-attaching flaking paint, to saturate the colours, and to act as a durable protective coating. It is now recognised that these coatings tend to darken over time as a result of chemical reactions in the oil/resin component and can increase the fragility of mortar joints. Furthermore, the wax attracts dirt, causing the surface to darken further.

The coating also restricts the free passage of moisture between the wall and the environment which can result in paint flaking and plaster damage. The wax layer was reduced as far as possible without causing damage to the underlying paint.

Doom painting
before restoration

1. Cleaning trials: Removing or reducing the discoloured wax-based coating – the wax was removed/reduced using xylene/acetone/isopropanol (0.62/0.25/0.12 mix) in free solvent form applied by swab. This method afforded greater flexibility and control than using a poultice method, especially in areas where the priority was consolidation rather than wax removal.

In general the paint had a good level of cohesion although some areas that had been protected from the wax coating by residual overlying limewash had a slightly friable, powdery surface. These areas were lighter in tone than the previously exposed and wax-coated surrounding paint. A weak solution of Paraloid B72 (3-5 per cent in acetone) was applied to these areas as a consolidant and to saturate the colours. Flaking paint and ground required reattachment before the cleaning/wax treatment could be carried out to avoid the risk of inadvertent loss. This was undertaken using solutions of Primal B60A (a water-based acrylic colloidal dispersion) applied through tissue.
